## Appreciating the History

## Enduring "Trial by Fire"

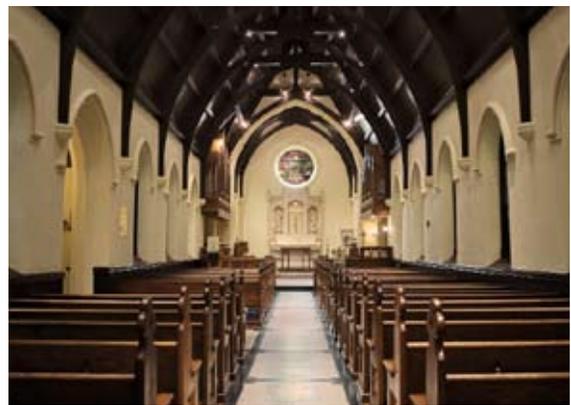
*Interior View of St. Bernard's Church after extensive restoration and reconstruction.*

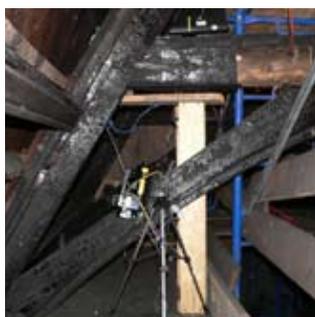
A large portion of the architecture is the roof structure, with arched heavy timber trusses forming a king post at the center. Two critical concerns were the extent of the fire damage and the degree to

which the wooden truss system might have been compromised by intense heat from the fire. HBA employed a wood scientist to make infrared x-rays to determine the truss construction; he also performed resistance drilling where wood rot along the eaves was suspected. These innovative detection techniques, along with the nature of the collaboration among the consultants, informed the stabilization approach and became the basis of a paper presented at an international conference on non-destructive testing held in Varena, Italy in September 2008.

The findings from the extensive non-destructive testing allowed the structural engineers to determine the precise level of intervention needed to stabilize the truss structure. The x-rays uncovered a truss system made up of small structural members, all of which needed to be reinforced

to insure the stability of the roof framing. Plates were custom designed and carefully vetted by HBA to insure that they fitted as discreetly as possible. The engineers were able to preserve a large amount of the partially burnt framing, which was painted once the reinforcement plates had been installed. The structural stabilization also included the use of recycled wood for the replacement of sill plates where there had been extensive damage.

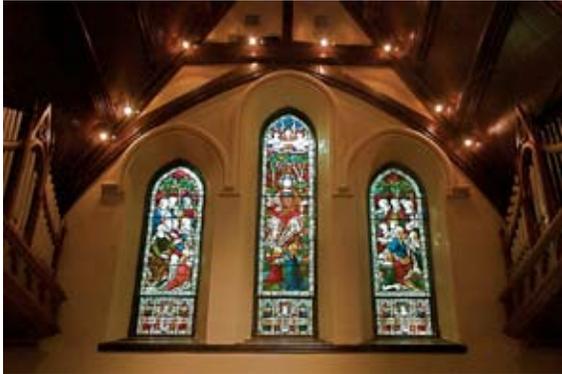
*Restored stained glass windows in the nave with new LED light fixtures.*
