## Appreciating the History

## Enduring "Trial by Fire"

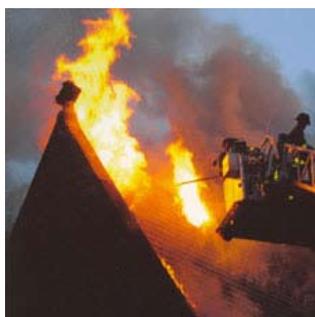
In the Fall of 2004, the church suffered a major fire that damaged much of the original historic fabric on both the interior and exterior. When fire companies arrived, 40-foot-high flames were seen shooting out of the tower windows. This tragic fire was probably caused when cloths being used to shellac new furniture in the sacristy were placed in an open trash-bin and apparently combusted spontaneously. This was not the church's first encounter with disaster; in 1957 an electrical fire in the tower caused near identical damage to the fire in 2004. By the time this fire was brought under control and extinguished, the church had sustained several million dollars of damage.
